RE: Field Oversight Report

Injection Wells Installation Event

Former Hewlett Packard Voluntary Remediation Project

FIELD OVERSIGHT REPORT

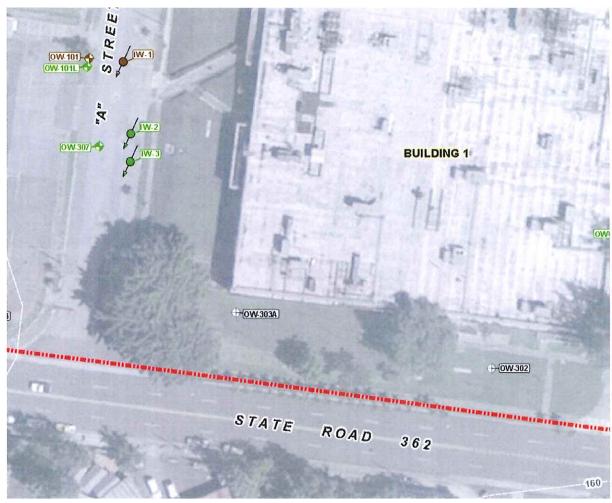
Three injection wells were going to be installed for the use of injecting carbon-amended water and bioaugmentation culture into the subsurface. Two shallow injection wells, IW-2 and IW-3, were going to be approximately 30 to 40 feet deep 2 and located 20 to 30 feet east and upgradient of monitoring well OW-307, parallel with estimated groundwater contours. One shallow injection well, IW-1, will be approximately 15 to 20 feet deep and located 20 to 30 feet east and upgradient of monitoring well OW-101. The approximate locations of the injection wells are shown in Figure 1 (IBSWP, 2015). Permits were obtained for the installation of the proposed injection wells and for the proposed subsurface injections. Clearance of utilities were performed on March 4, 2016. Equipment mobilization and preparation was observed. The following activities were observed:

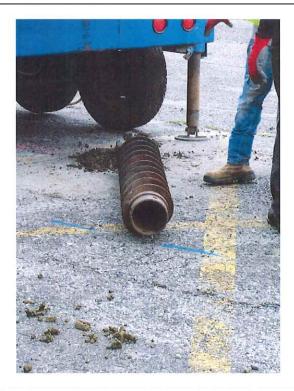
Photo No. 6

- Once determined the location of the well, the drilling personnel started the drilling process manually, until reaching 4 ft depth. See photos #1 and #2.
- The soil coming out of the hole was contained in 55 gallons drums. See photo #3.
- Assembly of the drill rig was prepared. See photos #4 and #5
- Using the 4 in drilling rod the drilling begins. See photo #6.
- Finally, the well goes down to 20 ft and water was encountered.
- Using 20 ft of 4 in diameter piping the injection well was installed. See photos #7 and #8.
- Once the piping completed, the annular space was filled with 12 ft of sand (see photo #9), 8 ft of bentonite and wetted with water (see photos #10 and #11) and completed with cement.
- The cover and casing of the monitoring well was going to be installed the next day to allow time for the pipe to settle.
